## MARINE ACCIDENT REPORT

SINKING OF THE  
M/V CHESTER A. POLING  
NEAR CAPE ANN, MASSACHUSETTS  
JANUARY 10, 1977

REPORT NUMBER: NTSB-MAR-78-7

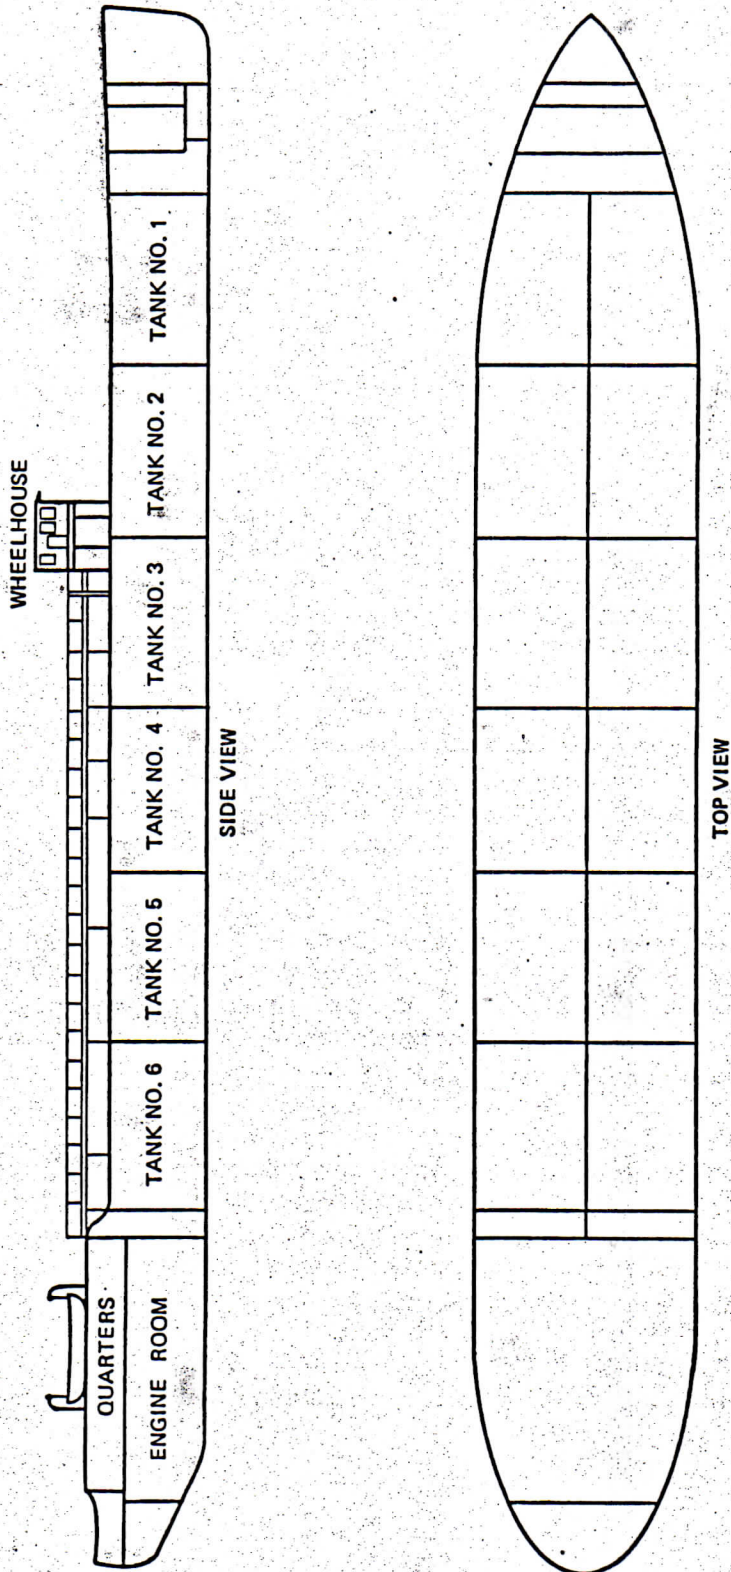
Figure 2. Vessel arrangement of the M/V CHESTER A. POLING.

On her last voyage, the POLING carried ballast in tanks Nos. 2, 3, 4, and 5. This created a hull bending moment in the sagging condition. Had the ballast been distributed over the length of the vessel, such as by loading ballast in tanks Nos. 1, 3, 4, and 6, the bending moment could have been significantly reduced. This would have enabled the POLING to endure more severe seas than was possible in the actual loaded condition. In fact, the POLING might have been able to endure a seaway with significant wave heights up to about 30 ft. Since the ballasting equipment operated properly, and there were no operational considerations that required specific tanks to be filled in a certain order, a better ballast arrangement could have been used. The Safety Board concludes that the distribution of ballast water in the POLING was improper.

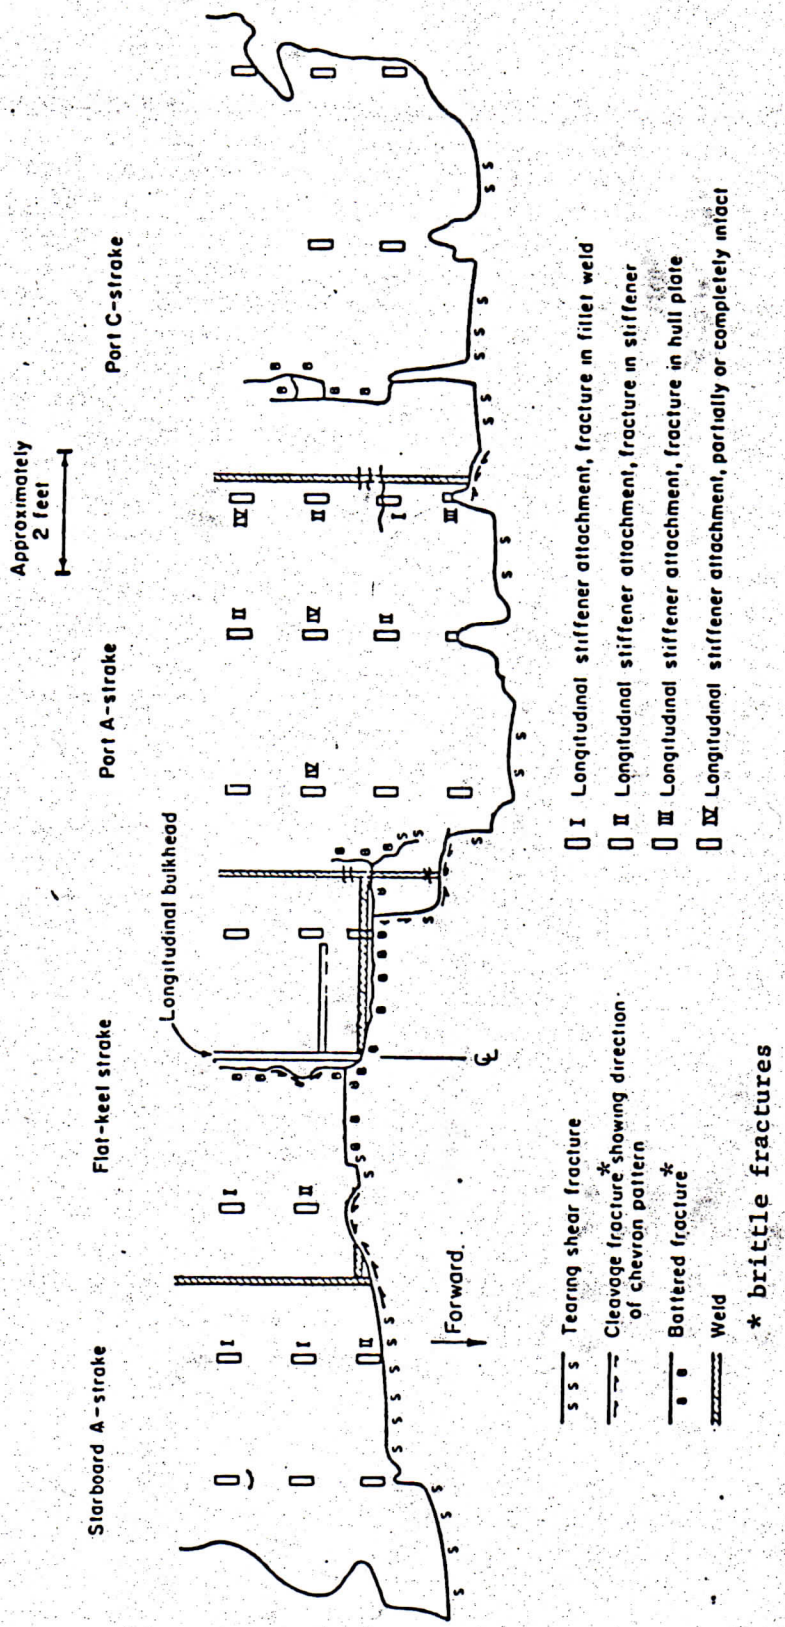
Figure 3. Diagram of fracture in the bottom hull plate of the M/V CHESTER A. POLING. (The inside surface of the plate is shown.)

After these initial examinations, a section of the bottom, about 5 ft long and 24 ft wide, was removed from the fracture area of the sunken stern section. (See figure 3.) This section of plating, with some longitudinal stiffeners still attached, was examined by an independent metallurgical laboratory.<sup>7/</sup> The chemical composition and tensile properties of the steel were determined to be acceptable. The steel samples exhibited yield strengths of about 40 ksi and ultimate strengths of about 63 ksi. Charpy V-Notch impact tests indicated absorbed energy values of 2.5 to 5.0 ft-lbs at test temperatures from 0° to 60° F for the longitudinal stiffener tested. Examination of another longitudinal stiffener revealed a brittle fracture with chevron marks pointing toward the end of the flange. The flat keel plate was determined to have a nil-ductility transition temperature of 45° F by drop weight testing methods.

A longitudinal stiffener on the salvaged bottom section showed a completely battered fracture face. The damage to the fracture face was consistent with damage from multiple impacts. To cause this damage, both ends of the broken stiffener must have fit closely together after breaking and must have struck each other forcefully several times. If the stiffener had been initially torn away from the hull plate, or if it had failed because of local buckling, it is unlikely that the ends could have mated precisely enough to cause the observed damage. Local buckling of the stiffener also would have been unlikely because the POLING's

The stiffener steel exhibited low notch toughness at temperatures below 60° F, and the ambient seawater temperature during the POLING's last voyage was about 30° F. Stress concentrations would have existed near the cut-outs in the webs of the stiffeners. A high loading rate was probably induced by the POLING's slamming into waves. Combined with the high tensile stresses, these factors could have caused the brittle fracture of a stiffener. Chevron marks on the fracture face of a longitudinal stiffener pointed toward the end of the stiffener's flange, indicating that a brittle fracture had originated at the end of the flange. When steel fractures brittlely, a sharp cracking noise results. Crewmembers on the POLING heard similar noises before the vessel broke. Therefore, the Safety Board concludes that the initial failure was the brittle fracture of a bottom longitudinal stiffener during tensile loading.

After the stiffener failed, the critical buckling stress of the two adjacent plating panels would have been reduced to about 9 ksi. This reduction and the compressive stresses in the bottom structure when the vessel was hogging probably caused the bottom plating to buckle. The salvaged bottom plating showed evidence of buckling.

As several waves passed the POLING, the buckled plating was straightened by tensile loading and then buckled again by compressive loading several times. This caused some remaining stiffeners to be pulled away from the bottom plating, which further reduced the strength of the bottom structure. Continued reversal of loading of the buckled, unstiffened bottom plating caused multiple cracking on both the top and bottom surfaces of the bottom plating, as seen on the salvaged section. Several brittle fractures occurred in welds, extended into the plating, and then continued as shear failures under the extreme overload conditions. Thus, the remaining parts of the bottom finally failed because of tensile overload.
